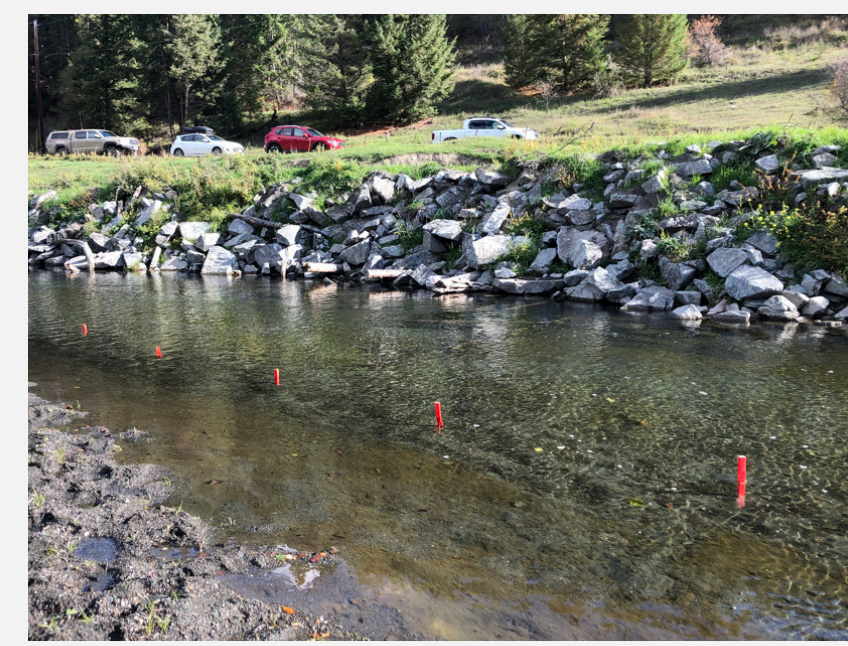
Figure 2. Riprap and CWD of Site B bankside, Louis Creek, BC. 2021.

Streambank restorations included the introduction of riprap (human-placed boulders providing both streambed and streambank protection), coarse woody debris (CWD) and replanting vegetation which increases bankside stability and improves stream conditions for local fish populations (coho, chinook & rainbow trout), and other species, including invertebrates (Figure 2).

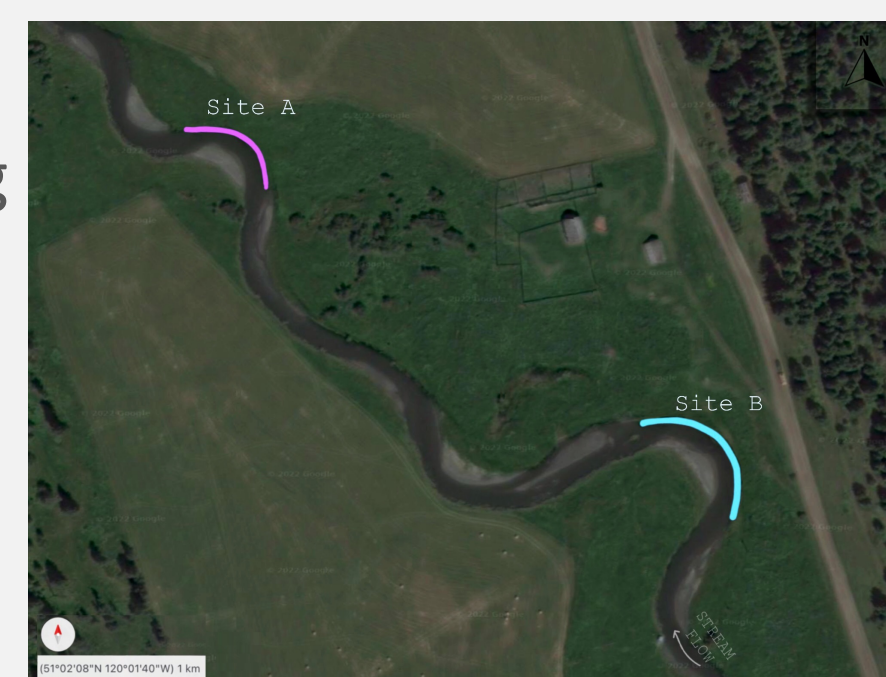
Figure 3. Site A and Site B of Louis Creek, BC.

- This project saw the use of two sampling sites, Site A and Site B – Site A was located downstream and was restored over the winter of 2021/2022; Site B, further upstream, was restored over the winter of 2020/2021 (Figure 3).

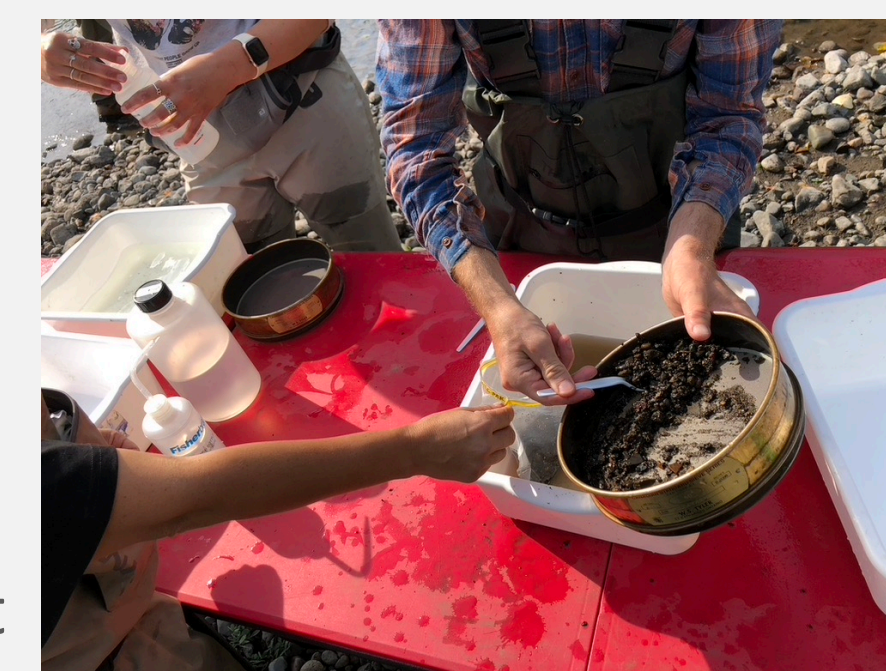
Figure 4. Collecting and bagging samples from Louis Creek, BC.

- 10 sampling units at each site (1 x 2 m each, totaling 20 m²) were sectioned off.
- Using a modified '3-minute travelling kick', samples were collected in a 250 μm mesh D-frame net.
- Samples were preserved in 80% ethanol in Whirl-Pak™ bags (Figure 4).

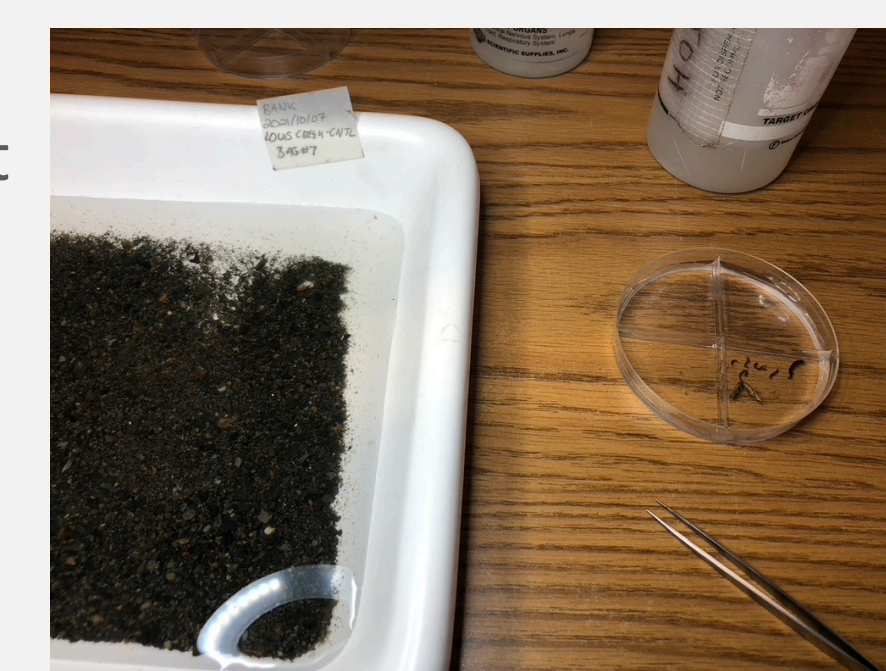
Figure 5. Removing invertebrates from sediment collected at respective sampling sites to be later identified and measured.

- Invertebrates were removed from all sediment, organic matter and rocks (Figure 5)
- Invertebrates were identified to family level
- Biomass was calculated by measuring the length of each invertebrate and using length-weight regression equations
- Response variables included total abundance and total Ephemeroptera, Plecoptera, Trichoptera (EPT) and the ratio of EPT to Diptera (EPT/D)

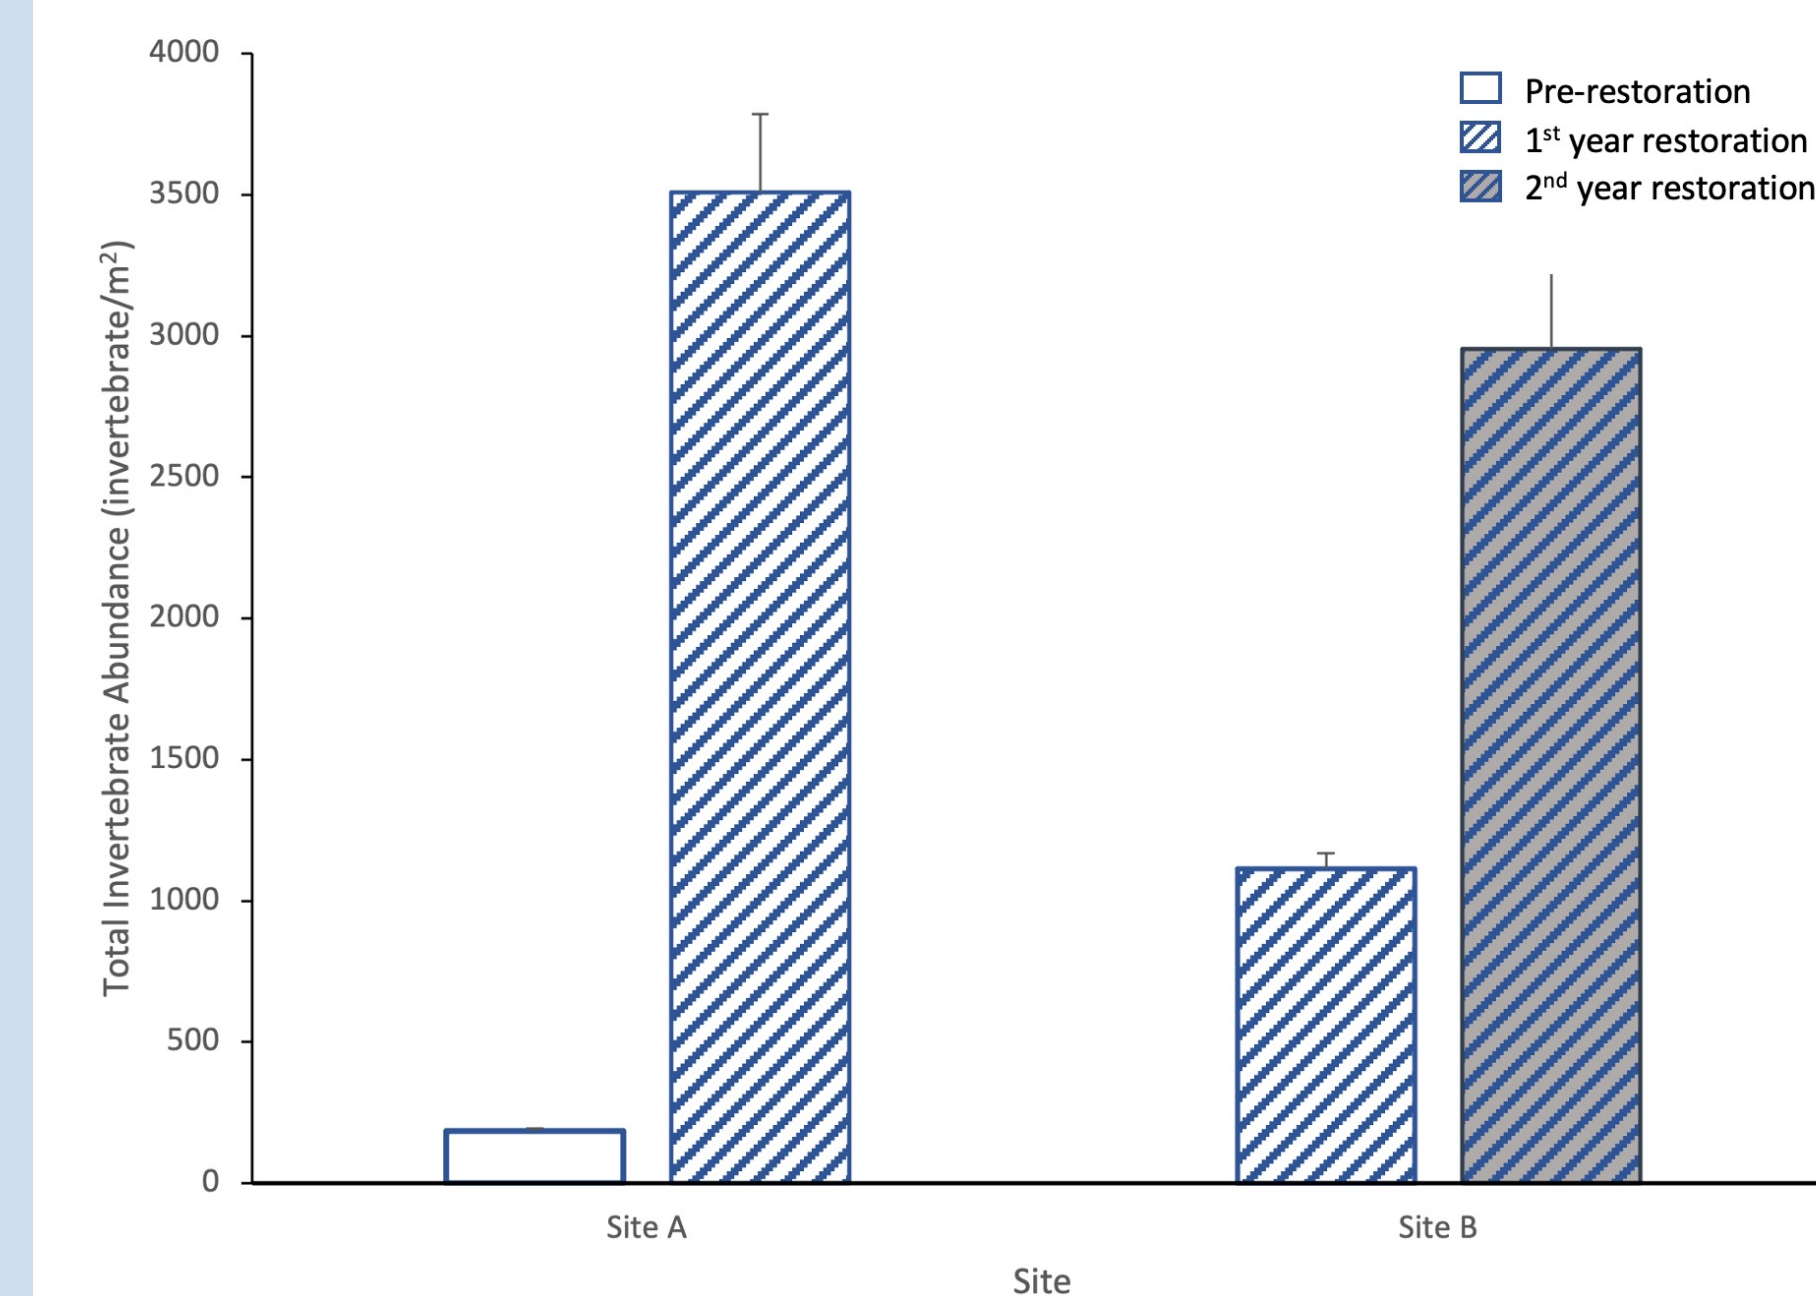
Figure 7. Mean total abundance (Invertebrates/m²) of both Site A, before and after restoration, and Site B, first- and second-year post-restoration with error bars that display 95% confidence intervals. Louis Creek, BC.

- Restoration efforts saw a significant increase of total abundance, total EPT and EPT/D at both Site A and Site B (Figures 7, 8 & 9 respectively).
- Unlike Site A, Site B did not see a significant change in total biomass (Figure 6).

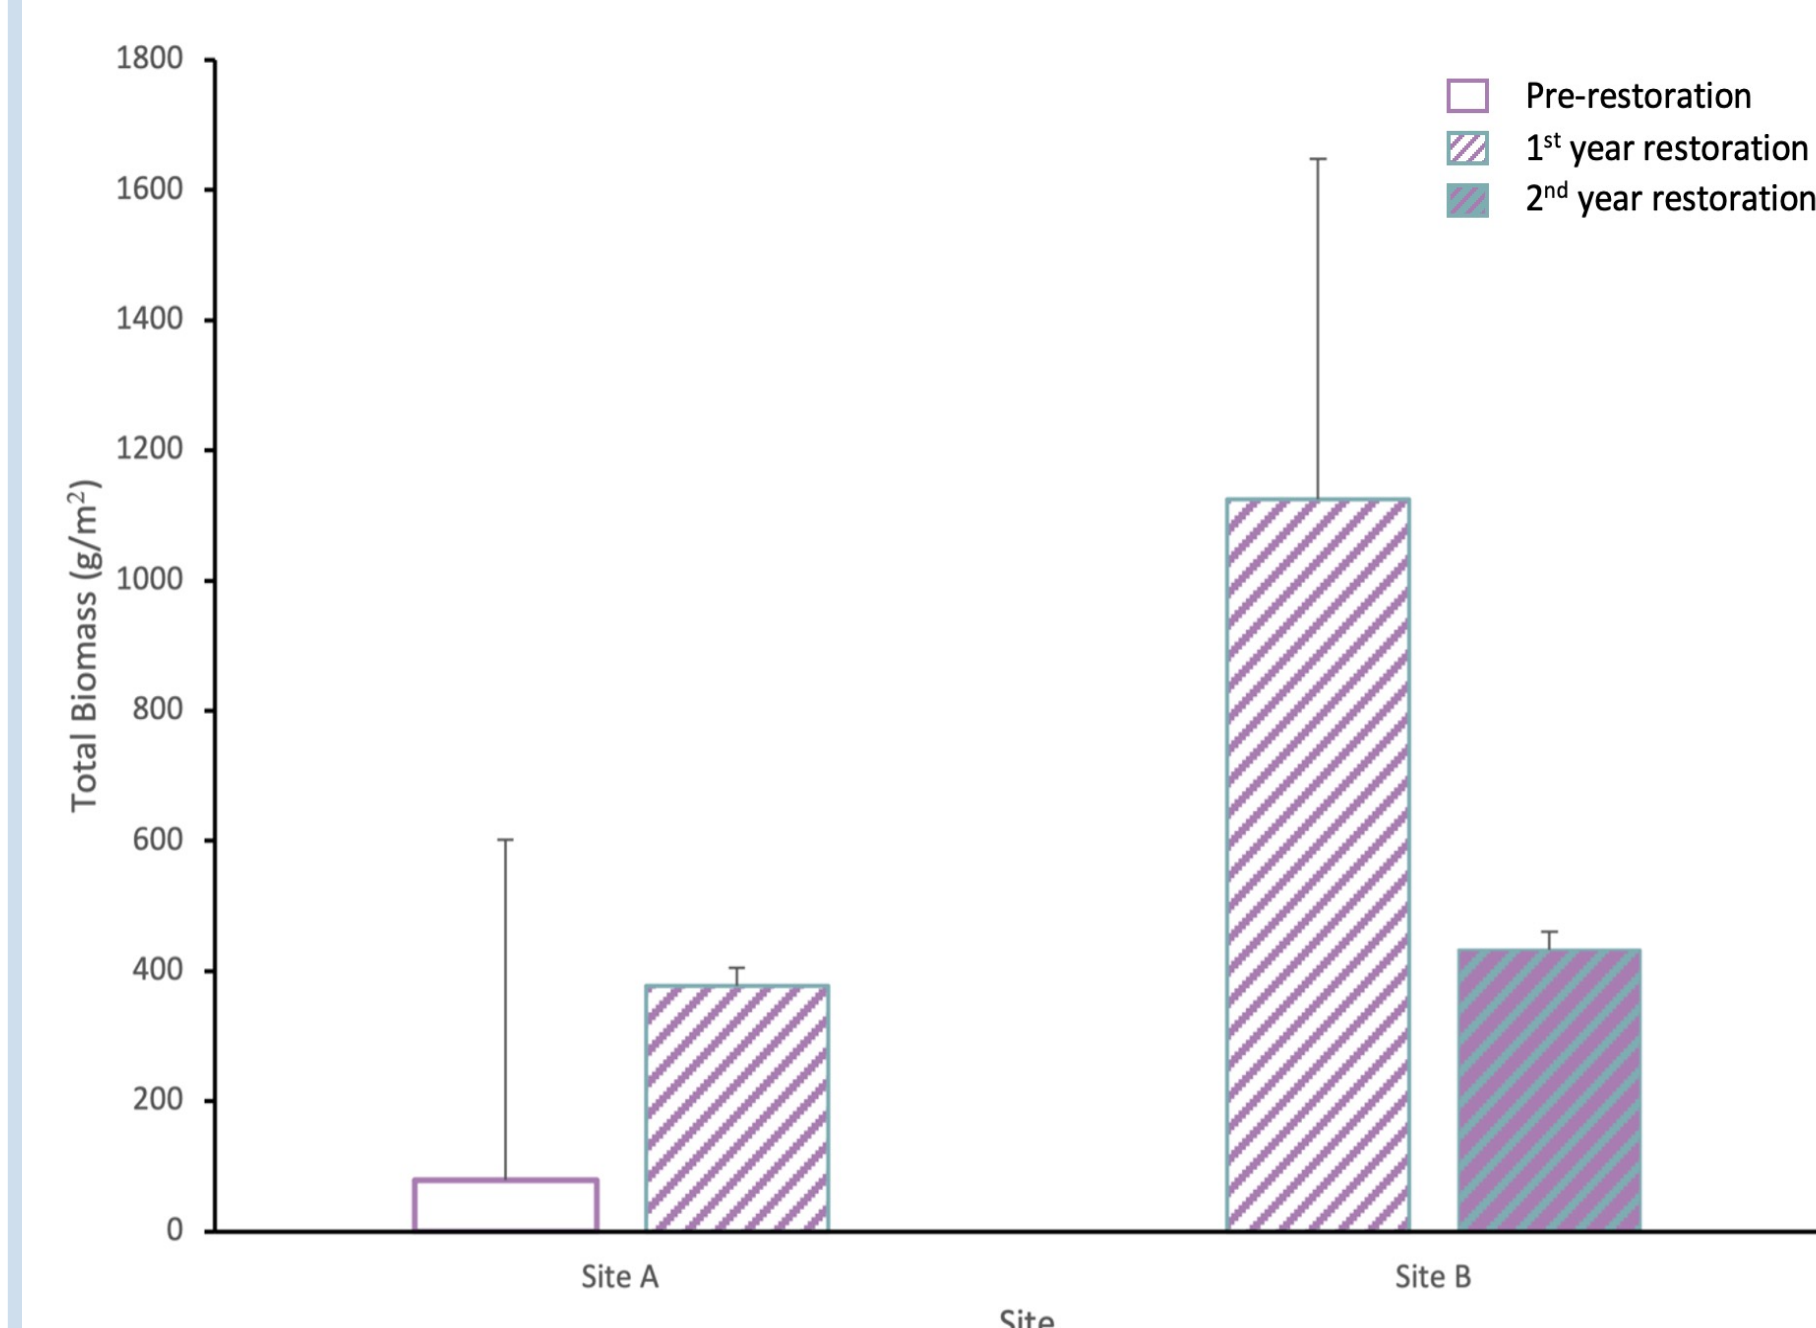
Figure 6. Mean total biomass (g/m²) of both Site A, before and after restoration, and Site B, first- and second-year post-restoration with error bars that display 95% confidence intervals. Louis Creek, BC.
